The effects of jet exhaust blast impingements on graphite-epoxy composites.

Hampey, John Michael

THESIS

June 1981

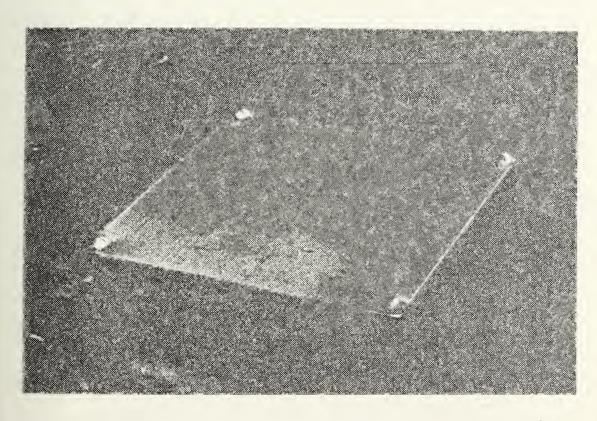
FIGURE 12: COMPOSITE AFTER JET BLAST TEST. NOTE CARBON BUILDUP

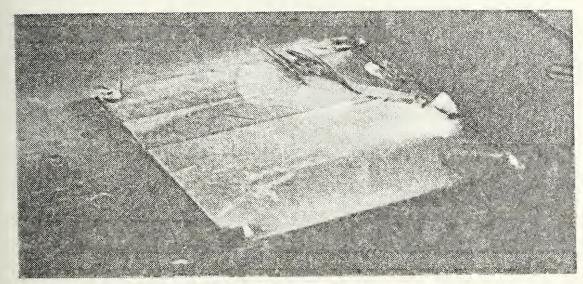
FIGURE 19: 1/2 COMPOSITE AFTER TESTING. NOTE DELAMINATION TEST NUMBER 6

The one possible explanation for the contradiction is that the temperature in Test 6 far exceeded the recorded value of 230°C, as the temperature in this test was 230°C. It was noted that the temperature in Test 6 was far in excess of that recorded and this also seems to verify that belief.

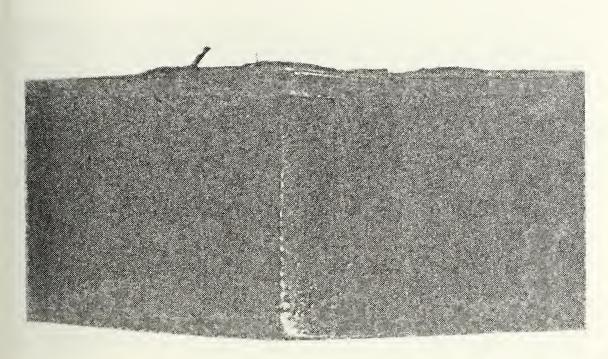
The 1/4 inch sample showed slight delamination of the composite in a very small area in one dorner (Figure 21). The results of the shear test for the 1/4 inch sample indicates that small areas of delamination do not imply a degradation of the entire composite.

FIGURE 21: 1/4 COMPOSITE AFTER TEST 13 (10X MAGNIFICATION).
NOTE DELAMINATION AT CORNER

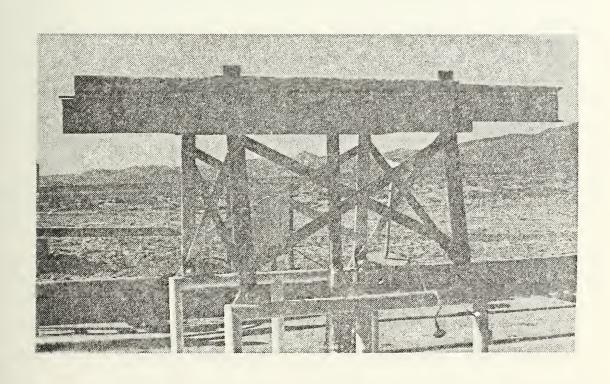
FIGURE 23: WINGBOX AT CONCLUSION OF TESTING. NOTE SOOT BUILD-UP ON WINGBOX
